## Updating the Software on Your Touchscreen Fryer

**NOTE: THE SOFTWARE UPDATE PROCESS HAS CHANGED! PLEASE FOLLOW THESE REVISED INSTRUCTIONS TO UPDATE SOFTWARE FILES. FAILURE TO FOLLOW THE STEPS MAY RESULT IN A FAILED SOFTWARE UPDATE.**

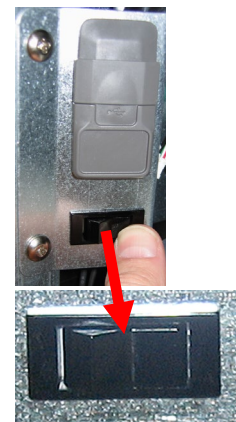
To power cycle the system, **PUSH and HOLD** the black toggle reset switch for **60 SECONDS**. The reset switch is located either under the far-left USB port (see photos to the right). If the switch is not accessible, unplug the fryer or turn off the breaker to the fryer.

- Power cycle the system as shown in step 2 for **60 SECONDS**. **Failure to press and hold the reset switch long enough, may cause an incomplete software update.**
