Updating the Software on Your Touchscreen Fryer

NOTE: THE SOFTWARE UPDATE PROCESS HAS CHANGED! PLEASE FOLLOW THESE REVISED INSTRUCTIONS TO UPDATE SOFTWARE FILES. FAILURE TO FOLLOW THE STEPS MAY RESULT IN A FAILED SOFTWARE UPDATE.

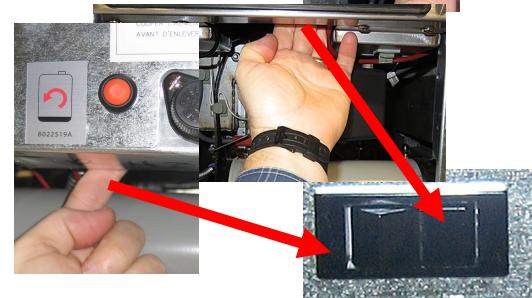
To power cycle the system, **PUSH and HOLD** the black toggle reset switch for **60 SECONDS**. The reset switch is located either under the USB port, near the USB port, under the left control box or directly behind the JIB reset switch (see photos to the right). If the switch is not accessible, unplug the fryer or turn off the breaker to the fryer.

9. Power cycle the system as shown in step 2 for **60 SECONDS**. **Failure to press and hold the reset switch long enough, may cause an incomplete software update.**
